**CORRIB ONSHORE PIPELINE
ADDITIONAL INFORMATION**

Prepared for:

Shell E&P (Ireland) Ltd.

AGEC Ltd
The Grainstore
Singletons Lane
Bagenalstown
Co. Carlow

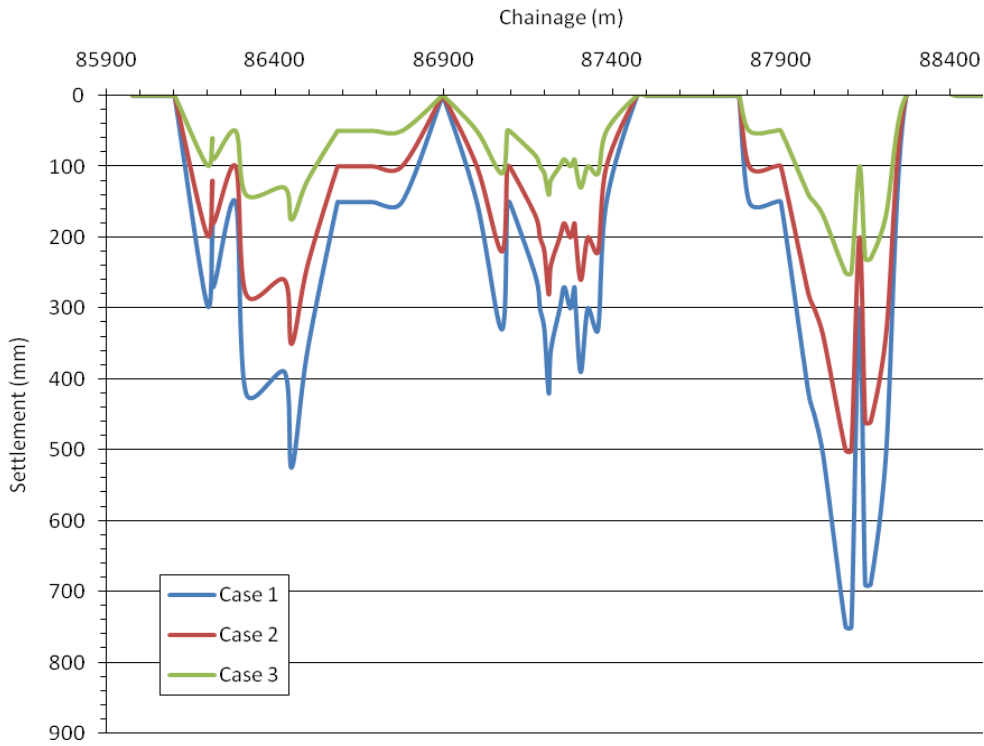
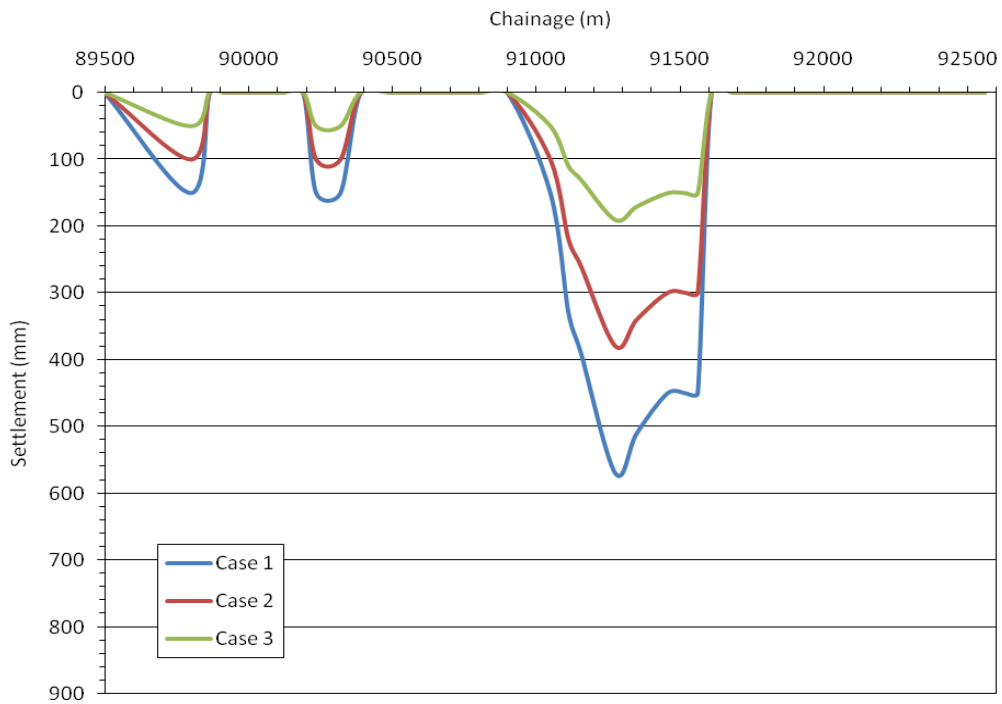
Figure 1.1 Predicted Settlement of Peat below Stone Road

(a) Predicted Settlement in Rossport Commonage

(b) Predicted Settlement in South of Sruwaddacon Bay

- (b) The predicted settlement profile along the road is shown in Figure 1.1.
 - (c) The results for particularly Case (1), which assumes there is no stone within the peat, are considered unrealistic. Stone will penetrate into any peat underlying the stone road as described elsewhere. Furthermore, a substantial proportion of settlement is likely to occur prior to pipeline laying.

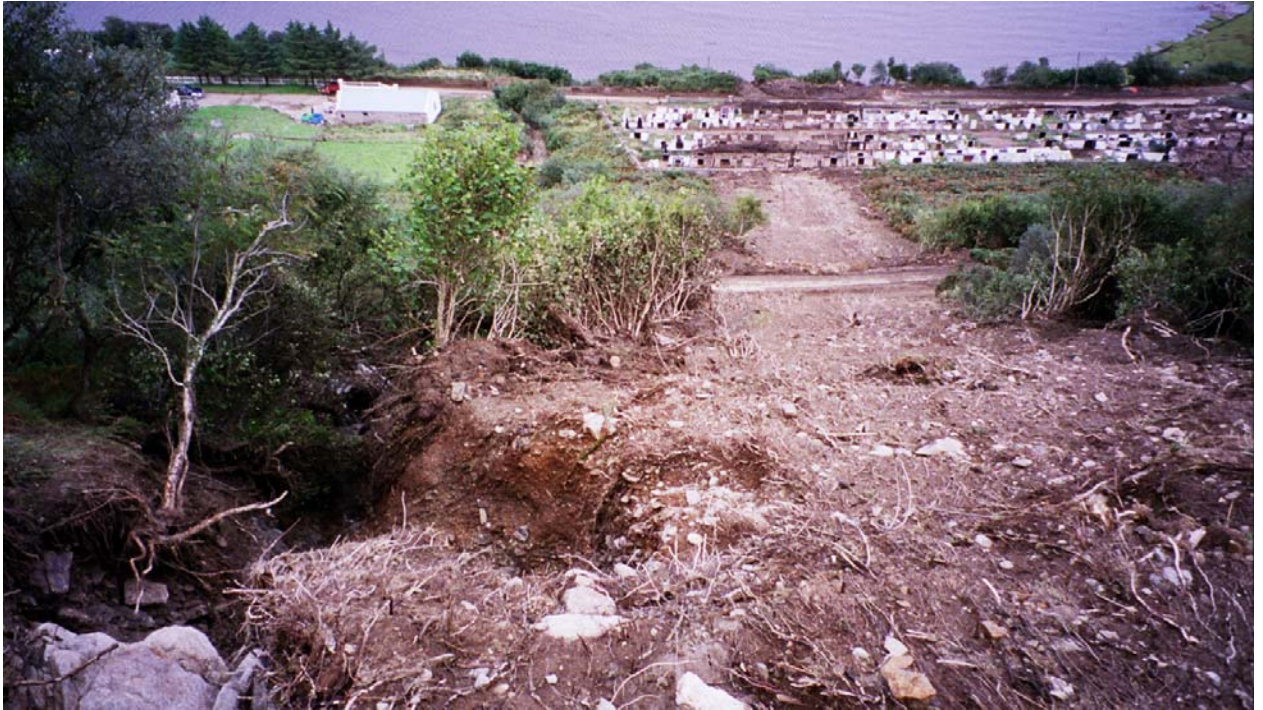
Figure 4.1 View Looking Down Landslide Debris Trail

On the steep northeast-facing upper slopes of Barnacuille Mountain there are some 13 separate failure zones. Several landslide scars merged to form larger scars. The debris from these landslides involved peat, soil and boulders that passed directly downslope initially overland and in placed became channelised.

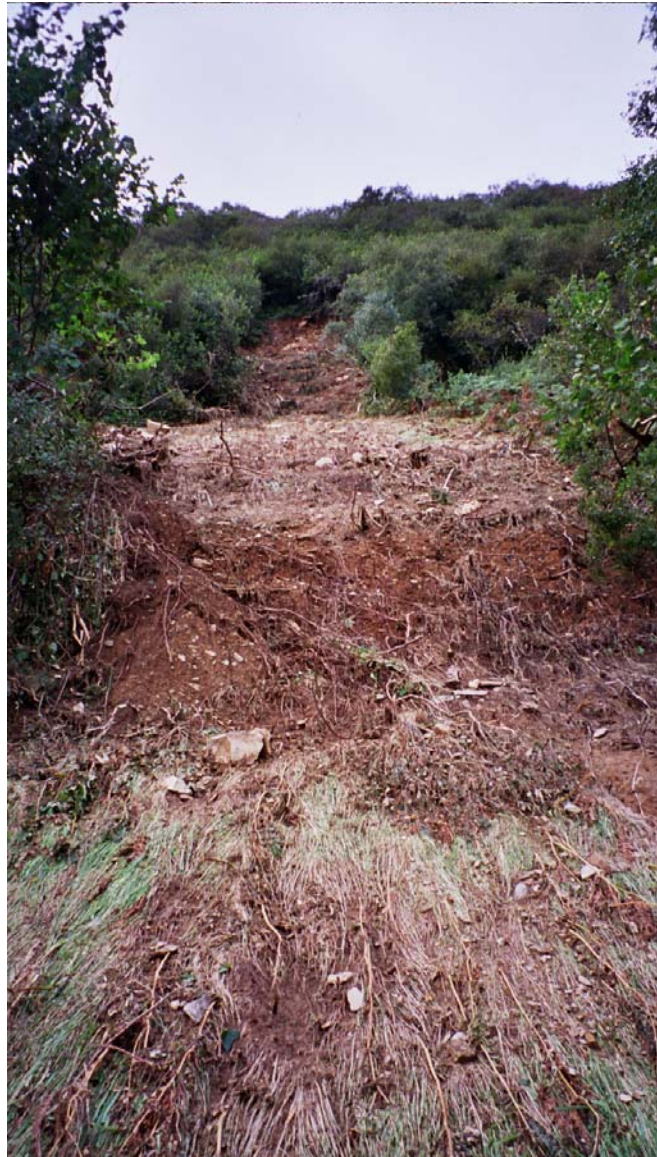
Figure 4.2 Views Looking Up Landslide Debris Trail
